# CONDITION APPRAISAL

## HAVILAND STREET PARKING GARAGE

NORWALK, CONNECTICUT

JANUARY 2026

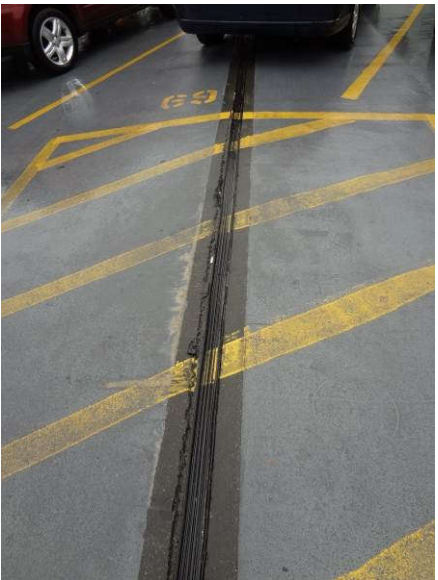
Photo No. 21

- Two expansion joints are currently installed at third points along the deck as well as the entry/exit apron. Expansion joints are typically created within a structure to allow for thermal movements within the structure in response to ambient temperature variation and are also sometimes necessary to separate structural elements which are anticipated to move contrary to one another due to differential settlement or potential seismic activity (such as stair towers). These expansion joints need to be closed off to prevent water infiltration through the joint opening or to allow for a smooth transition between adjoining structural elements; typically, a flexible material or gland is designed to handle the extent of movements experienced. These glands can be comprised of any number of materials and need to be tough enough to handle vehicular and/or pedestrian traffic as may be required and still allow for unimpeded pedestrian access.

The replacement of these two expansion joint systems is being addressed as part of the current repair program (**reference Photo Nos. 21 & 22**).

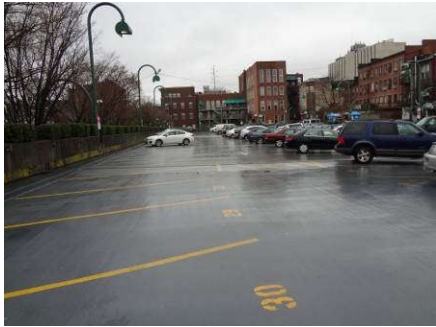
Photo No. 23

- A traffic bearing membrane has been installed over the concrete slab (*reference Photo Nos. 23, 24, 25 & 26*). Traffic bearing membranes are approximately 85%-90% effective as moisture and chloride screens inhibiting future chloride-ion migration into the deck. An elastomeric membrane will also traverse cracks that may form and joints that may be tooled.

**DESMAN** considers repair of the system critical to maintain its waterproofing integrity and protect the concrete substrate below; following the repair of the concrete, repair and recoating of the membrane system is being addressed as part of the current repair program.

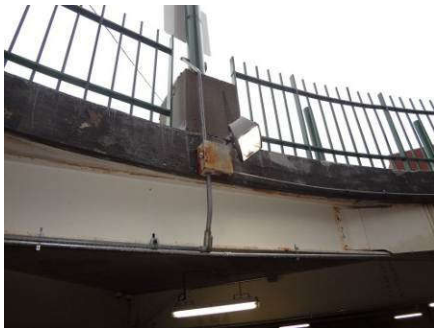
Photo No. 30

- Generally speaking, the electrical system is in good condition; miscellaneous repair is required to replace corroded boxes and segments of steel conduit. **DESMAN** recommends that funds be programmed for miscellaneous electrical repairs (i.e. deteriorated conduit, damaged fixtures, etc.) that may be necessary over time (*reference Photo Nos. 30 & 31*)

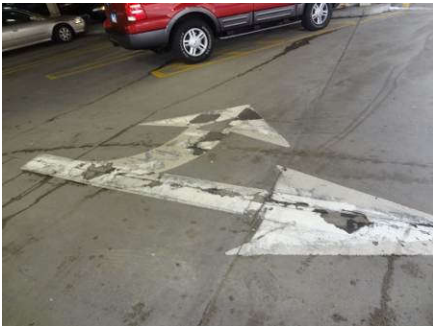
Photo No. 34

- As noted previously, **DESMAN** recommends that the metal framing be primed and repainted to both protect and enhance its appearance. Besides the framing, there are various other metal structures and materials throughout the garage, such as the clearance bar assembly by the entrance, as well as fencing, stair railings, and the light poles, that **DESMAN** recommends be programmed for re-painting as well; we note that re-painting of these materials is being addressed as part of the current repair program (*reference Photo No. 33*)
- Following completion of repairs, **DESMAN** recommends that all traffic markings (i.e. parking stalls, directional arrows, etc.) be re-painted. **DESMAN** recommends that all conflicting markings

**(reference Photo Nos. 34 & 35)**, if any, first be removed prior to re-painting, and all ADA requirements be updated accordingly.

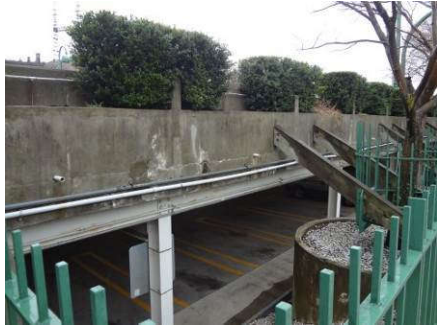
Photo No. 36

Although the waterproofing materials in the planters were replaced in 2008, the planters are now abandoned but the materials remain. Therefore, moisture continues to be a concern simply due to the nature of the water being collected. **DESMAN** recommends that the planter materials be removed and the planters properly waterproofed. **(reference Photo No. 36)**

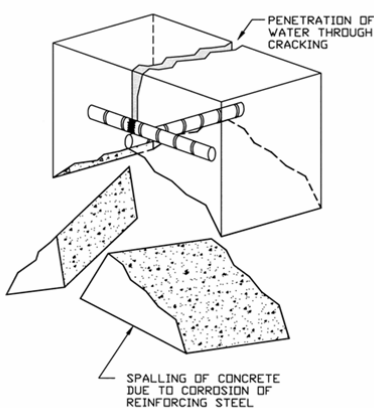
Fig. B

Corrosion of reinforcing steel or other embedded ferrous items such as electrical conduit is a second major factor contributing to deterioration of reinforced concrete (*Reference Fig B*).
