CONDITION APPRAISAL

MARITIME PARKING GARAGE

NORWALK, CONNECTICUT

JANUARY 2026

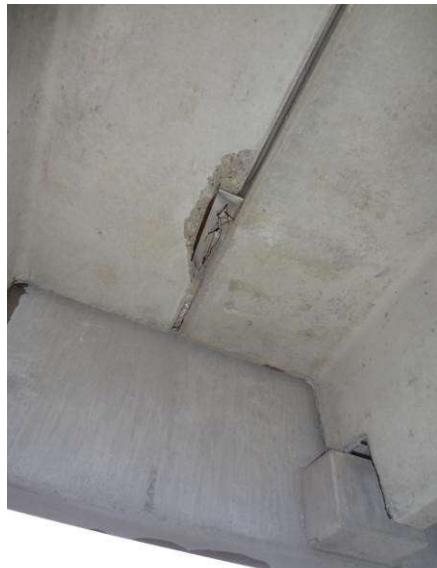
Photo No. 13

- Interim repairs have been performed as **DESMAN** noted that select shear connector assemblies associated spalled/delaminated shallow-depth concrete surrounding the connections have been repaired. The majority of the concrete repairs are performing well. Miscellaneous locations have failed and new spalls have formed, though, throughout the garage, and require attention once more. These locations have failed for a variety of reasons inclusive of, but not limited to, snow removal operations and the nature of the original construction providing an embedment depth which is too shallow as discussed previously.

While the interim repairs incorporated a cementitious polymer-modified concrete repair mortar, **DESMAN** now recommends the use of an epoxy/aggregate repair mortar to infill the shallow surface spalls. This material can be applied with minimal surface preparation and its material properties and enhanced bonding characteristics allow it to be feathered into the adjoining concrete surface. The recommended repair material is also more flexible than typical concrete/cementitious repair mortars. Similar periodic repairs at the shear connections throughout the garage can be expected throughout the useful life of this facility.

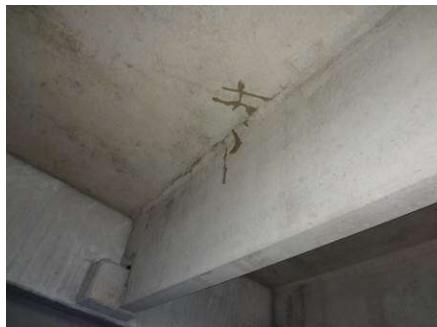
Photo No. 16

- Miscellaneous vertical and overhead concrete spalling was observed throughout the garage. Insufficient coverage of reinforcing steel and failed waterproofing above can allow moisture to access the steel, thus causing the spalling. Although cosmetic in nature, **DESMAN** recommends that these locations be repaired with a high-quality polymer modified repair mortar.

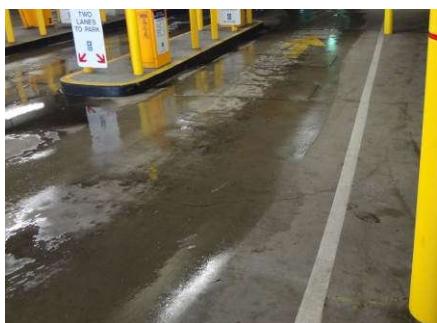
Photo No. 17

- Minor cracking, scaling, and other deterioration mechanisms exist throughout the slab-on-grade (Level 1) (**reference Photo No. 17**). Since the slab-on-grade is typically considered a lesser priority than a supported deck, **DESMAN** recommends that **PN** monitor the slab-on-grade to make certain no trip-and-fall hazards present themselves and the deterioration mechanisms don't expand or become exacerbated.

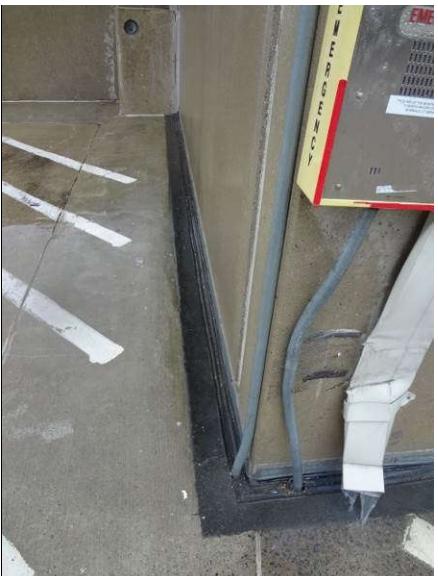
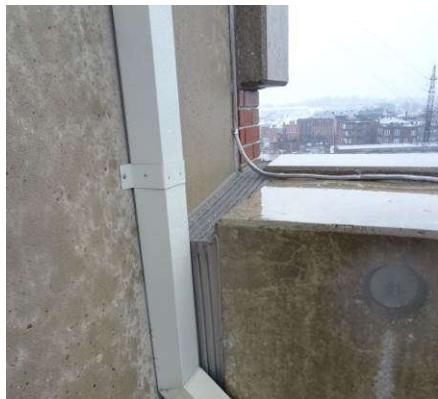
- Expansion joints are currently installed around the three stair towers (**reference Photo Nos. 25 & 26**). Expansion joints are typically created within a structure to allow for thermal movements within the structure in response to ambient temperature variation and are also sometimes necessary to separate structural elements which are anticipated to move contrary to one another due to differential settlement or potential seismic activity (such as stair towers). These expansion joints need to be closed off to prevent water infiltration through the joint opening or to allow for a smooth transition between

- All expansion joint glands located throughout the facility would benefit from periodic cleaning to remove dirt and debris which tends to accumulate within the folds of the accordion shaped glands. Debris which collects within the expansion joints can

restrict proper joint movement and cause premature failure of the joint. It is recommended that this expansion joint cleaning be performed on a weekly basis, or as a minimum on a monthly basis.

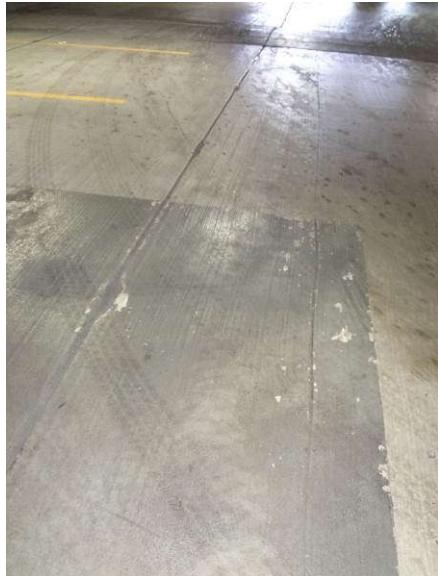
Photo No. 31

- A traffic bearing membrane has been installed over the pre-topped precast surfaces of Level 2 (recoated in 2011), which coincides with the office spaces below. Traffic bearing membranes are approximately 85%-90% effective as moisture and chloride screens inhibiting future chloride-ion migration into the deck. An elastomeric membrane will also traverse cracks that may form and joints that may be tooled.
- Generally speaking, the membrane installation is performing well, maintaining its bond to the concrete and its non-slip aggregate texture. However, certain areas are wearing more quickly than other locations, typically within the drive lane portions or in turning areas.

- Although a traffic bearing membrane is a superior chloride and moisture screening product, it is costly to install and to maintain, particularly if installed on precast concrete garages with their many joints; each joint acts as a location where a membrane can fail as each joint presents a discontinuous edge in the membrane where water can potentially enter, thus failing the membrane from below

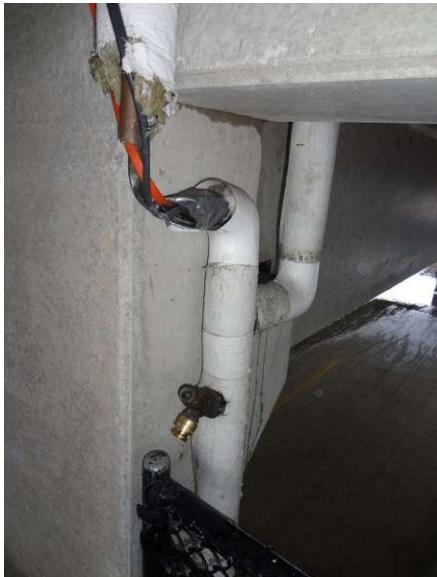
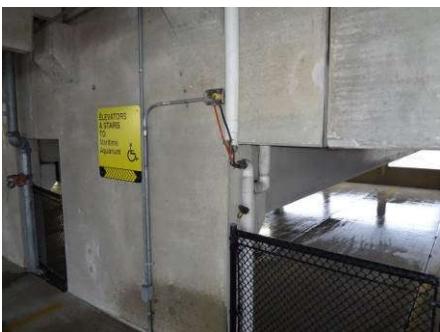
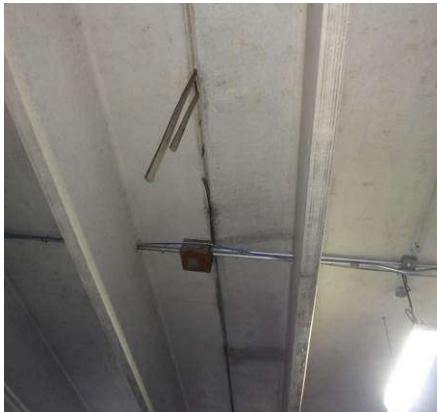
- Miscellaneous damaged drains and piping were observed throughout the garage, requiring repair and/or replacement. **DESMAN** recommends that all corroded grating and other components be replaced.

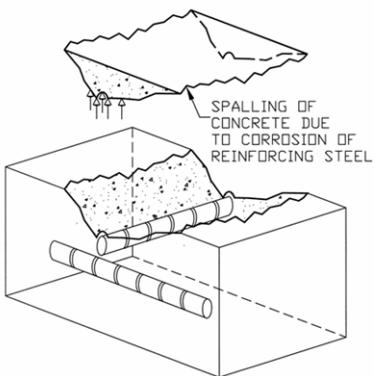
Fig. A

The primary cause of the majority of reinforced concrete deterioration within parking structures is directly related to the penetration of water into the concrete. Reinforcing corrosion, concrete scaling, water leakage, leaching, and concrete delamination are all caused at least partially by water penetration.

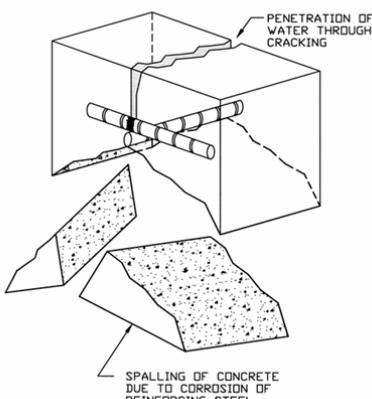
Fig. B

Corrosion of reinforcing steel or other embedded ferrous items such as electrical conduit is a second major factor contributing to deterioration of reinforced concrete (**Reference Fig B**).

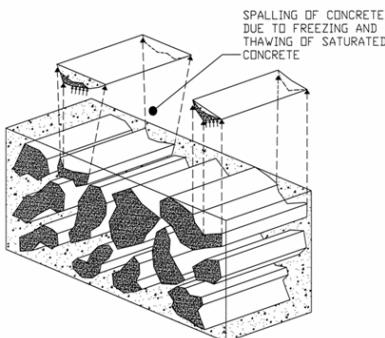
Fig. C

As previously mentioned, these pressures can cause progressive failure of the cement paste and result in scaling of the concrete, and delamination of concrete along subsurface fracture planes (**Reference Fig. C**).
