CONDITION APPRAISAL

SOUTH NORWALK RAILROAD TRAIN STATION PARKING GARAGE

NORWALK, CONNECTICUT

JANUARY 2026

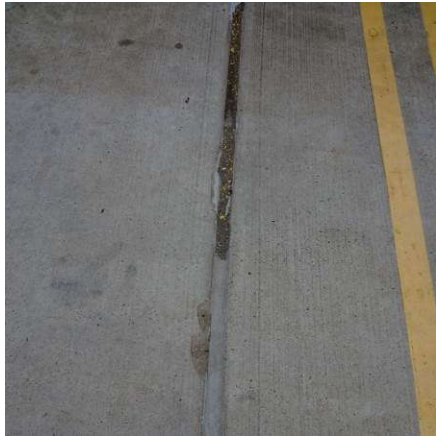
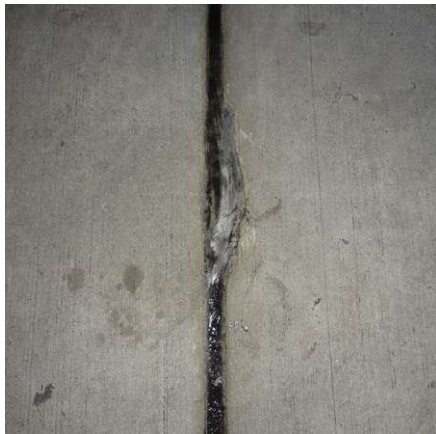
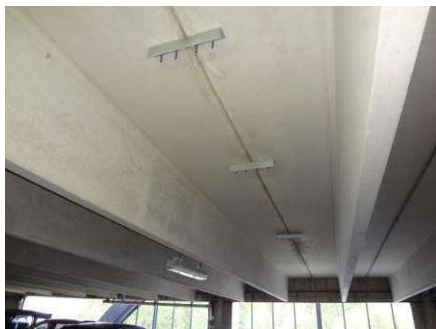
The surface spalling at the shear connections can also be the result of insufficient embedment depth of the shear connection assembly and the surrounding concrete being stressed beyond its tensile capacity during erection, unintended restrained thermal movements in the entire structure in response to ambient temperatures. Failure can also potentially occur due to a temporary overstress condition as a vehicle or combination of vehicles move across the deck and up through the garage, or during snow removal operations. Interim repairs have been performed as **DESMAN** noted that select shear connector assemblies associated spalled/delaminated shallow-depth

concrete surrounding the connections have been repaired. In some cases, external supplemental connections were installed where the existing connections had failed beyond repair. The majority of the concrete repairs are performing well. Miscellaneous locations have failed and new spalls have formed, though, throughout the garage, and require attention once more. These locations have failed for a variety of reasons inclusive of, but not limited to, snow removal operations and the nature of the original construction providing an embedment depth which is too shallow as discussed previously. While the interim repairs incorporated a cementitious polymer-modified concrete repair mortar, **DESMAN** now recommends the use of an epoxy/aggregate repair mortar to infill the shallow surface spalls. This material can be applied with minimal surface preparation and its material properties and enhanced bonding characteristics allow it to be feathered into the adjoining concrete surface. The recommended repair material is also more flexible than typical concrete/cementitious repair mortars. Similar periodic repairs at the shear connections throughout the garage can be expected throughout the useful life of this facility. The recommended epoxy/aggregate repair work required at the shear connections will need to be coordinated with waterproofing/sealant work needed as described later in this report.

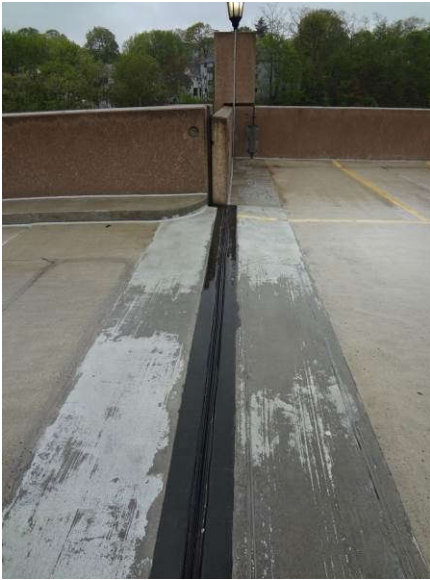
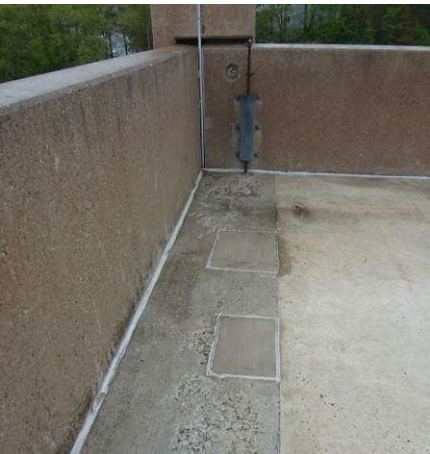
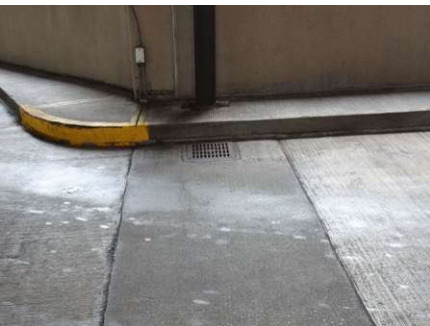
- Cast-in-place concrete aprons and pour strips are located throughout the garage, specifically along the interfaces of the ramps with the parking decks; the cast-in-place concrete appears to be performing well typically, however do require miscellaneous repair (*reference Photo Nos 13, 14 & 15*).

DESMAN recommends that the scaling and shallow-depth deterioration be repaired using an appropriate epoxy/aggregate repair mortar.

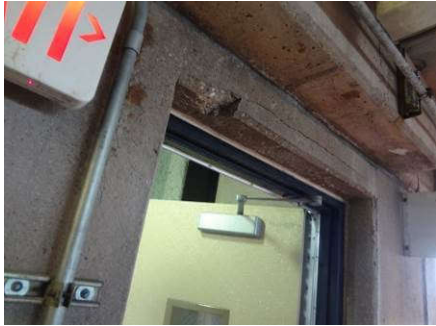
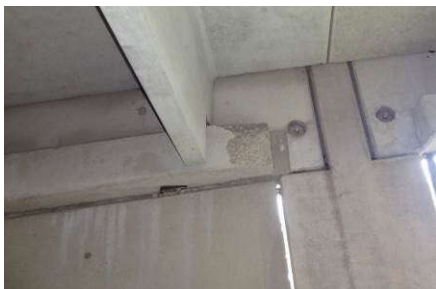
- Miscellaneous vertical and overhead concrete spalling was observed throughout the garage. Insufficient coverage of reinforcing steel and failed waterproofing above can allow moisture to access the steel, thus causing the spalling. Although cosmetic in nature, **DESMAN** recommends that these locations be repaired with a high-quality polymer modified repair mortar (*reference Photo Nos. 16 & 17*).

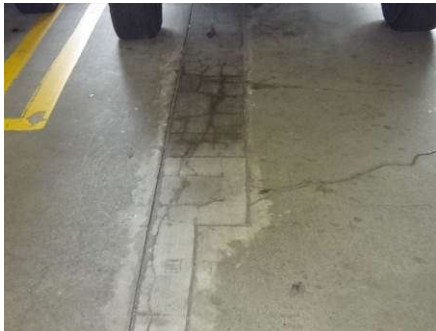
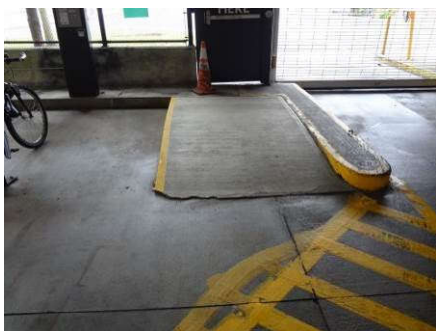
- Minor cracking, scaling, and other deterioration mechanisms exist throughout the slab-on-grade (Level 1). Since the slab-on-grade is typically considered a lesser priority than a supported deck, **DESMAN** recommends that **Laz** monitor the slab-on-grade to make certain no trip-and-fall hazards present themselves and the deterioration mechanisms don't expand or become exacerbated.

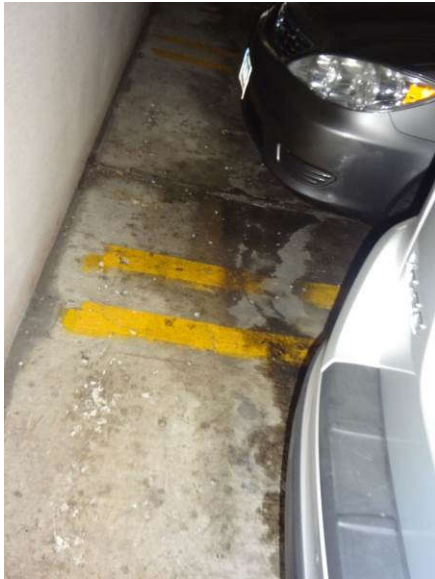
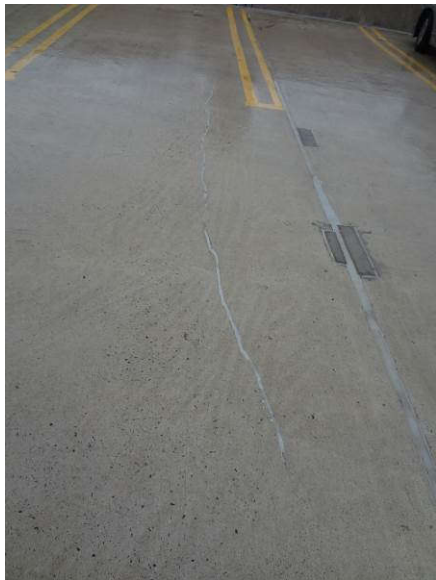
Miscellaneous sealant between adjacent precast concrete tees was observed to be exhibiting varying stages of age, which has led to some corrosion related deterioration at the tee connections. Although limited "spot" repairs have been performed, **DESMAN** typically recommends that more comprehensive repairs be programmed.

Limited "spot" repairs of tee-to-tee joints can be problematic as new polyurethane sealant does not adhere well to pre-existing or previously cured polyurethane sealant. "Spot" repairs can be accomplished, as evident from the recently performed repairs, but the pre-existing sealants must be thoroughly cleaned and wiped down with solvents to soften the surface and enhance the bond between old and new materials. Unless there is only limited tee-to-tee joint failures along a 60 foot parking bay, **DESMAN** typically recommends that the entire length of tee joint be removed and repaired in its entirety

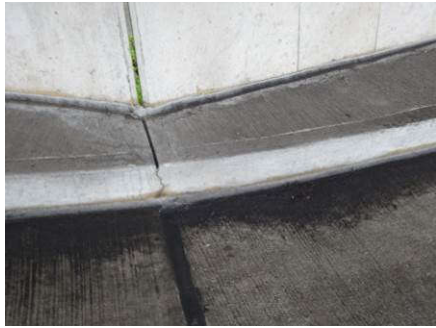
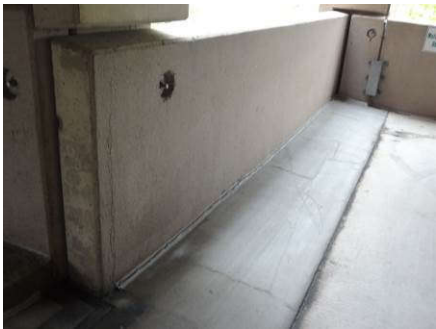
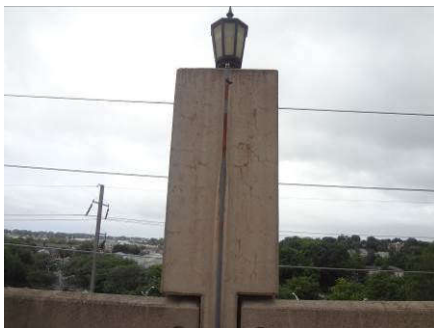
In conjunction with the replacement of the tee joint sealant, **DESMAN** observed miscellaneous tee edges have become misaligned and resulted in a slight vertical offset. Not only does this offset provide a potential trip-and-fall hazard, but the offset also

creates a dam for ponding and impedes water from reaching the intended drain. These tee edges should be ground down to allow the ponding to properly drain and to minimize potential trip-and-fall hazards.

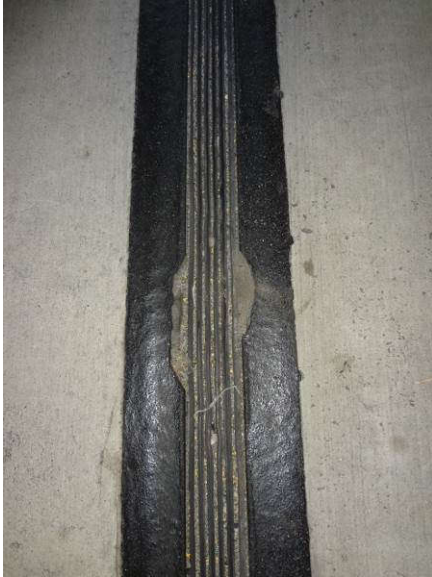
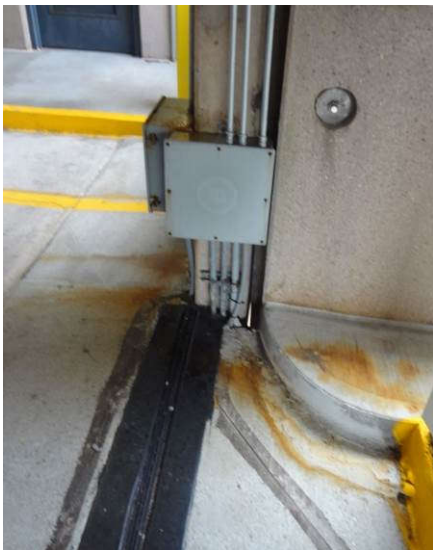
- Expansion joints are currently installed along column-lines 7 & 13 (third points along the deck), as well as column-lines 1 & 19 (ends of the deck, interfacing with the silo ramps) (*reference Photo Nos. 27 & 28*). Expansion joints are typically created within a structure to allow for thermal movements within the structure in response to ambient temperature variation and are also sometimes necessary to separate structural elements which are anticipated to move contrary to one another due to differential settlement or potential seismic activity (such as stair towers). These expansion joints need to be closed off to prevent water infiltration through the joint opening or to allow for a smooth transition between adjoining structural elements; typically, a flexible material or gland is designed to handle the extent of movements experienced. These glands can be comprised of any number of materials and need to be tough enough to handle vehicular and/or pedestrian traffic as may be required and still allow for unimpeded pedestrian access.

New expansion joint seals were installed on the roof level in 2011; the existing joint glands on the lower levels remained and are demonstrating their age due to wear and tear, as well as not providing a complete closure. **DESMAN** recommends that the existing glands be programmed for replacement as well, and new glands installed that continue vertically at the parapet interfaces and across the stair tower surfaces (adjacent to the parapets), providing a complete closed interface. Depending on budget requirements, the joint replacement could be reviewed on an annual basis; based upon the severity of actual conditions, it may be acceptable to perform "spot" repairs in lieu of full gland replacement, at which time **DESMAN** would assist **PN** in adjusting its budget. At the time of replacement, **DESMAN** recommends that penetrations through the glands be avoided; any penetration provides a means for the waterproofing integrity of the gland to be compromised. **DESMAN** therefore recommends that all electrical conduits be re-routed as required, as well as drainage piping be adjusted to avoid creating ponding on top of the glands; although the glands are designed to be watertight, constant exposure can aid in prematurely failing the gland

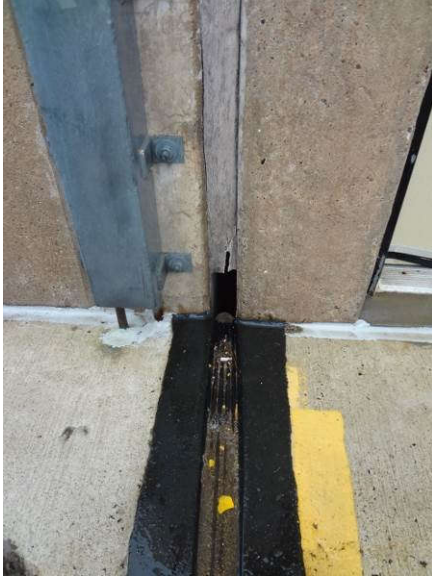
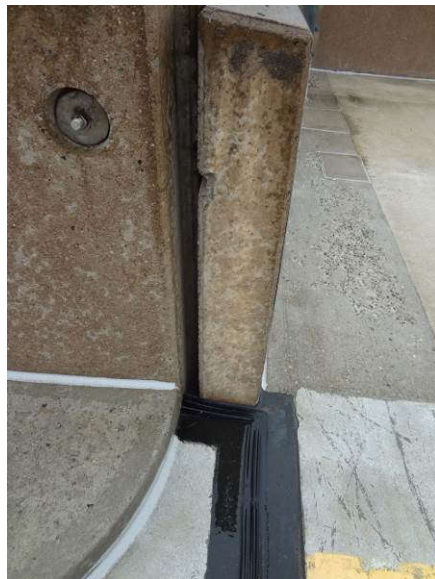
All expansion joint glands located throughout the facility would benefit from periodic cleaning to remove dirt and debris which tends to accumulate within the folds of the accordion shaped glands.

Debris which collects within the expansion joints can restrict proper joint movement and cause premature failure of the joint. It is recommended that this expansion joint cleaning be performed on a weekly basis, or as a minimum on a monthly basis.

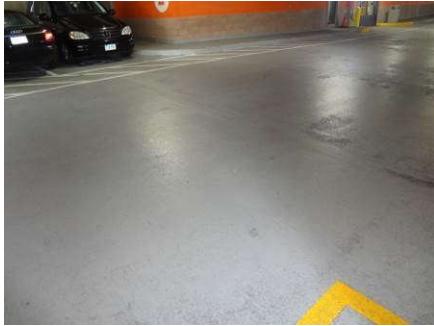
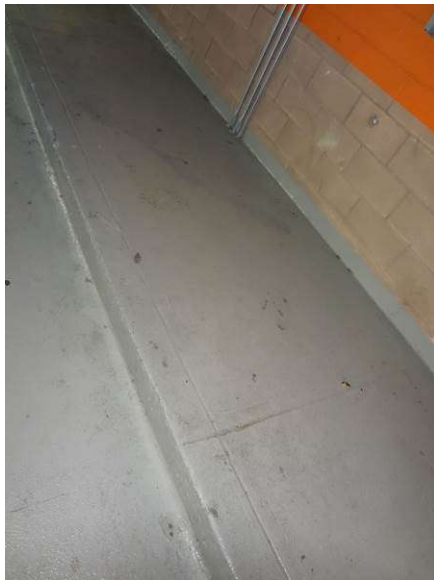
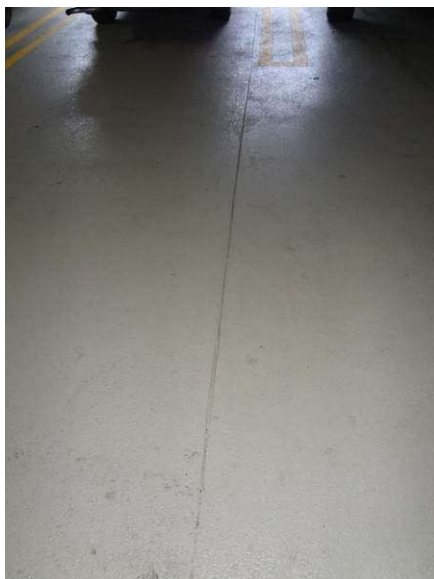
Generally speaking, the membrane installation is performing well, maintaining its bond to the concrete and its non-slip aggregate texture. However, certain areas are wearing more quickly than other location, typically within the drive lane

portions of the concrete aprons or in turning areas; although **DESMAN** does not consider the wearing a current concern, **DESMAN** recommends that it be monitored accordingly.

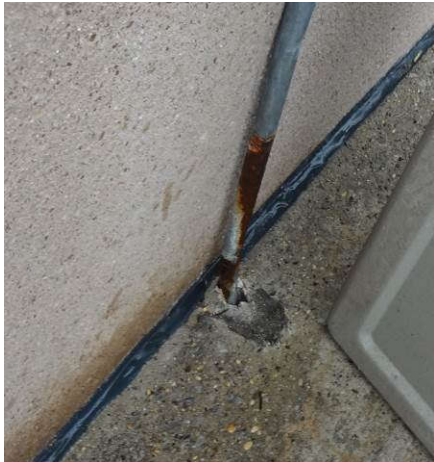
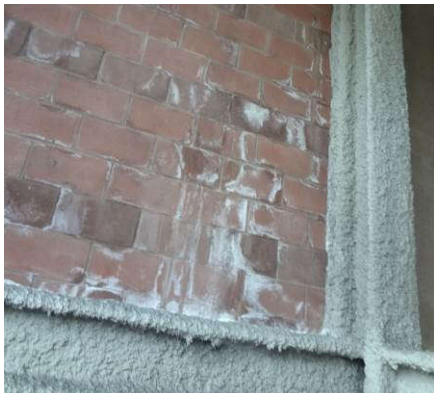
- New cove joint was installed in 2011 at the majority of all vertical and horizontal interfaces throughout the garage. Although the cove joint sealant appears to be intact, **DESMAN** did observe miscellaneous

locations that exhibit wear and tear. The failed cove joint sealant should be removed, the concrete surfaces properly cleaned and primed, and new, two-component, non-sag cove sealant should be installed.

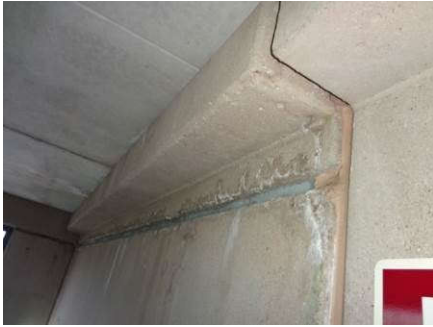
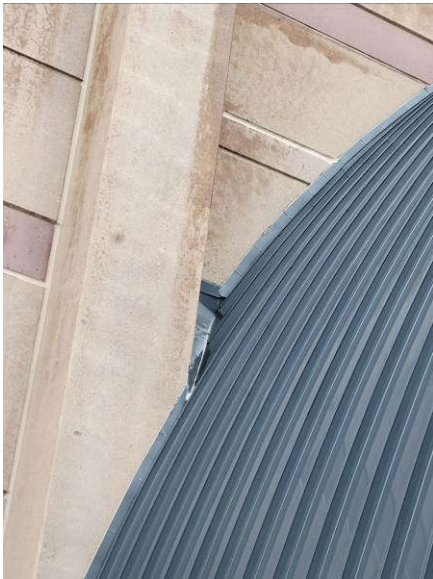
- **DESMAN** noted that the roof systems above the stair/elevator towers appear aged, as well as roofing over the main entrance and the roofing for the steps to the track platforms by the southern silo. Although the stair roofs, consisting of a concrete slab, appear to be dry, **DESMAN** observed various indications of moisture throughout the stair interiors, such as moisture stains on the masonry walls as well as corrosion throughout the electrical conduit system

and metal stair system; the metal roof for the steps to the platform is also exhibiting wear and tear. Considering the apparent age of the roof systems, **DESMAN** recommends that the roof systems be replaced; at a minimum, **DESMAN** recommends that all flashing be reviewed and replaced to prevent moisture from entering the masonry walls and exacerbating the existing deterioration, and all metal components be repaired and/or replaced as required.

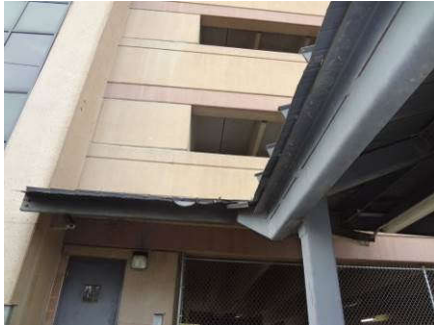
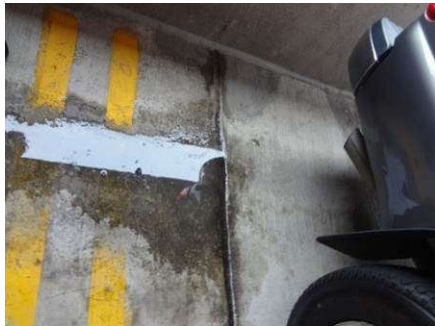
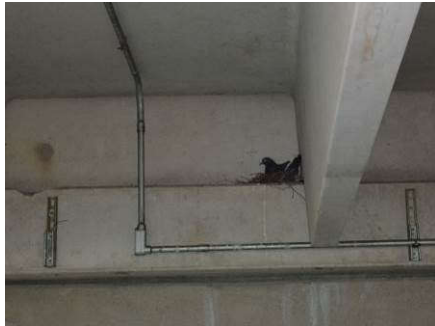
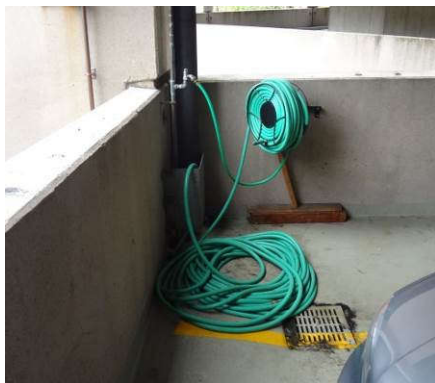
- Existing floor drainage continues to appear to perform satisfactorily with only minor pipe leakage identified; however, the floor drains throughout the ground level have deteriorated beyond repair and should be replaced. Minor areas of standing water, however, can be addressed with supplemental floor drains piped to the existing storm drainage system. Any drainage system within a parking facility should be flushed and tested annually to prevent debris collection and checked for system leaks.

In conjunction with the installation of supplemental drains, certain tee edges have become misaligned and resulted in a slight vertical offset (as previously noted). Not only does this offset provide a potential trip-and-fall hazard, but the offset also creates a dam for ponding and impedes water from reaching the intended drain. These tee edges should be ground down to allow the ponding to properly drain. Miscellaneous damaged drains and piping were observed throughout the garage, requiring repair and/or replacement. **DESMAN** recommends that all corroded grating and other components be replaced.

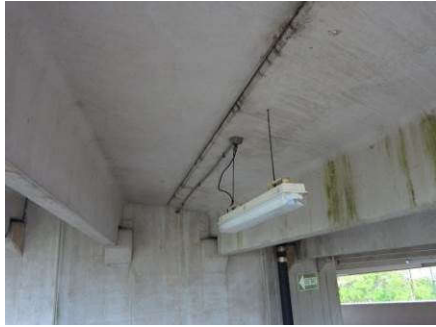
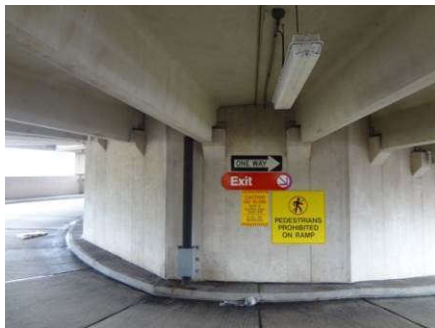
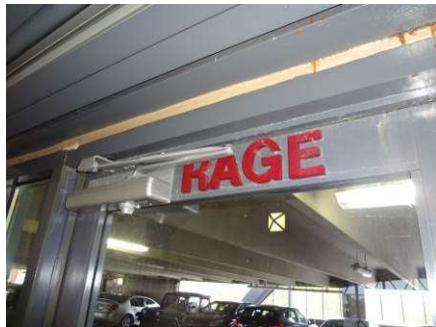
Generally speaking, the electrical system is in good condition; miscellaneous repair is required to replace corroded boxes and segments of steel conduit; **DESMAN** did observe miscellaneous missing fixtures in the silos. **DESMAN** recommends that funds be programmed for miscellaneous electrical repairs (i.e. deteriorated conduit, damaged fixtures, etc.) that may be necessary over time.

DESMAN typically recommends that mounting various structures (light fixtures) below the tee joints or conduit through joints be avoided since should the joint sealant fail adjacent to or above, moisture will penetrate the joint, exposing the conduit or fixture, corroding the conduit or fixture (**reference Photo No. 55**). Since this parking garage consists of a double-tee configuration, there is the opportunity to relocate the applicable conduit and fixtures to between the tee stems to avoid the tee joint and/or adjust the conduit so as to avoid penetration of the joint sealant.

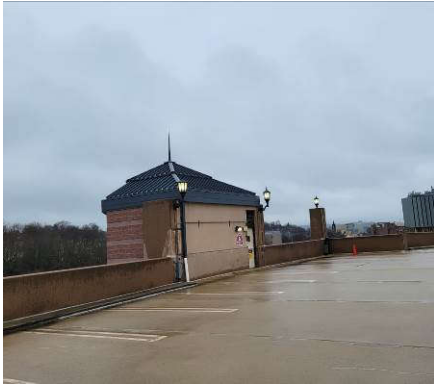
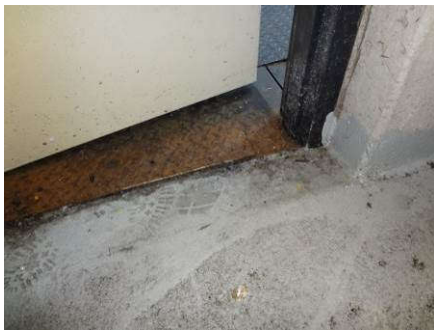
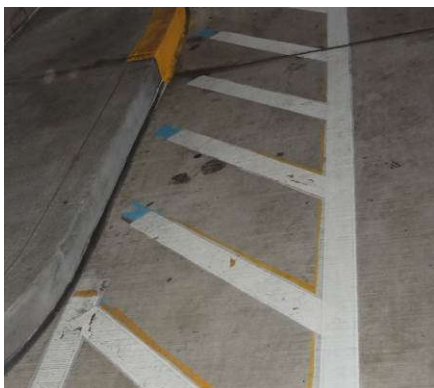
- Miscellaneous metal surfaces, throughout the garage, exhibit various stages of corrosion. **DESMAN** recommends that all miscellaneous metal surfaces

be cleaned, primed, and re-painted (i.e. doors and frames, stair handrails/guardrails, fire standpipe, etc.), to both protect and enhance their appearance.
