CONDITION APPRAISAL

YANKEE DOODLE PARKING GARAGE

NORWALK, CONNECTICUT

JANUARY 2026

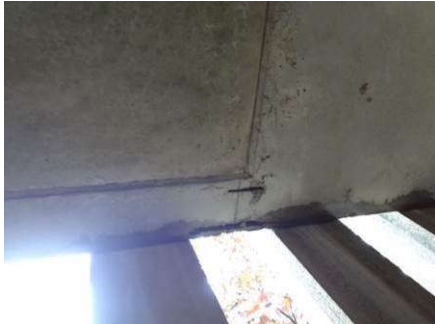
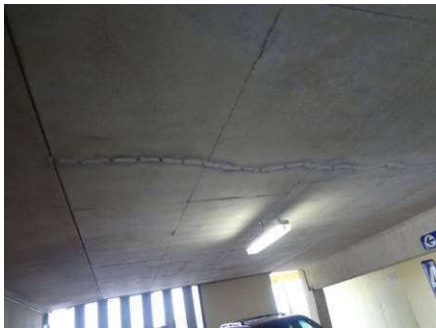
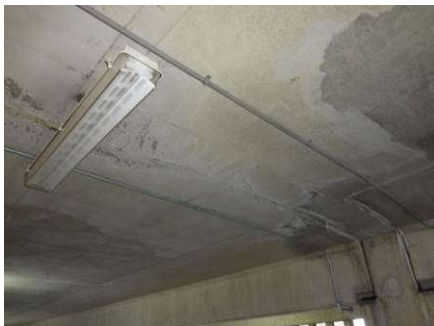
Limited areas, specifically related to the roof level, are currently being addressed. Additional areas, such as the balance of the roof level, though, remain to be addressed; considering the magnitude of cracking and the delaminations/spalling throughout the

garage, **DESMAN** recommends that all deteriorated concrete be repaired, followed then by an appropriate waterproofing membrane system. Any recommended concrete repair work should be coordinated with waterproofing/sealant work needed, as described later in this report.

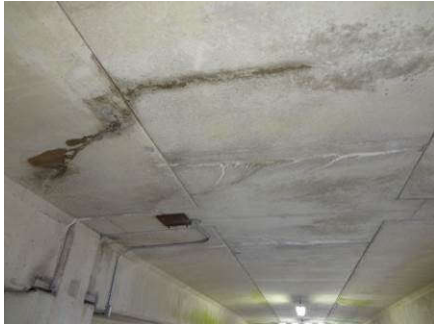
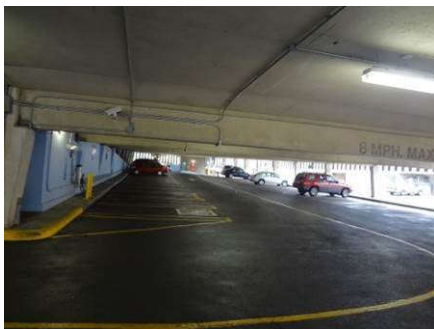
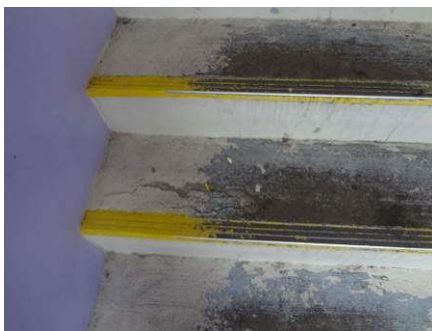
- The pre-cast tee beams are in good condition as well. However, miscellaneous vertical and overhead concrete spalling was observed throughout the garage. Insufficient coverage of reinforcing steel and failed waterproofing above can allow moisture to access the steel, thus causing the spalling. Although cosmetic in nature, **DESMAN** recommends that these locations be repaired with a high-quality polymer modified repair mortar.
- **DESMAN** also notes limited cracking is observed throughout the garage. Cracking can occur for a variety of reasons. **DESMAN** is not concerned that the cracking has compromised the structural integrity of the members, however, **DESMAN** does recommend that epoxy injection be performed to address the cracking to maintain the waterproofing integrity. **DESMAN** noted that epoxy injection has been performed on miscellaneous cracking previously.

For aesthetic and architectural enhancement, **DESMAN** recommends that the remaining excess epoxy and injection ports be removed and an

architectural coating be applied. A coating can provide a more uniform appearance, minimizing the visibility of the repairs such as by a typical exterior concrete paint system. Depending on the selected product, this can provide additional waterproofing protection by bridging any minor cracking and minimizing further moisture intrusion. Application of a coating can also enhance ambient lighting levels and assist in highlighting pedestrian entry/exit routes and areas of refuge throughout the garage. Since application of a coating is not required for structural or waterproofing integrity, assuming that epoxy injection repairs are performed, **DESMAN** has not included the projected cost for coating application in **DESMAN**'s recommended repair and capital improvement program; should **PN** be interested, **DESMAN** can provide the additional projected cost.

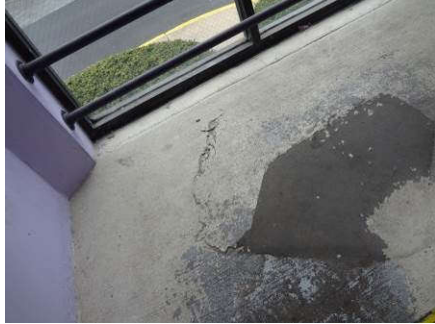
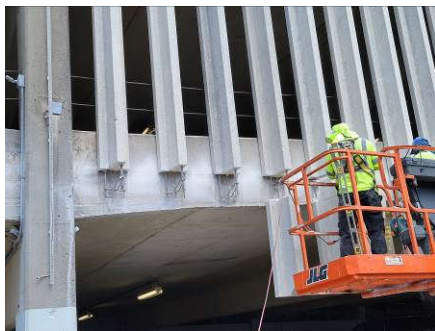
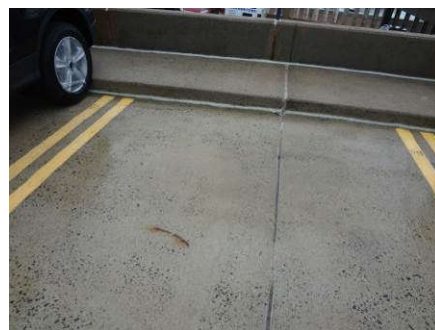
- Minor concrete spalling was observed in a limited number of areas of raised concrete curbs located around the parking facility, the majority being cosmetic and not the result of corrosion of embedded reinforcing steel, perhaps due to vehicular damage. **DESMAN** recommends that the spalling be patched with a high-quality polymer-modified repair mortar.
- Minor cracking, scaling, and other deterioration mechanisms exist throughout the asphalt slab-on-grade (Level 1) (*reference Photo No. 15*). Since the slab-on-grade is typically considered a lesser priority

than a supported deck, **DESMAN** recommends that **PN** monitor the slab-on-grade to make certain no trip-and-fall hazards present themselves and the deterioration mechanisms don't expand or become exacerbated.

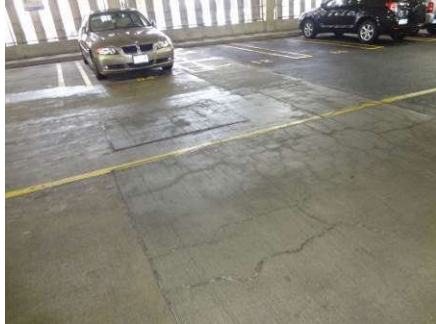
Photo No. 20

- Construction joints throughout the garage appear to be performing well, being replaced in 2010. As a general rule, the life expectancy of joint sealant is between 8 to 12 years depending on exposure and level of usage. Roof level joints, though, are exposed to more aggressive circumstances due to environmental conditions and snow plow damage, and lower levels experience comparatively more traffic than the upper levels of the facility.

- **DESMAN** recommends, though, that miscellaneous sealant be removed and replaced as may be required; **DESMAN** recommends that an allowance be programmed accordingly for miscellaneous repair.

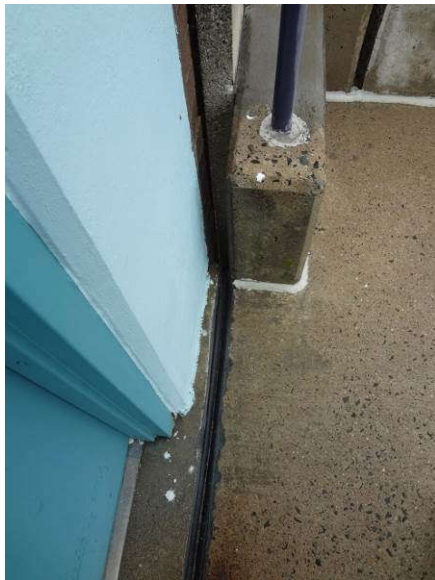
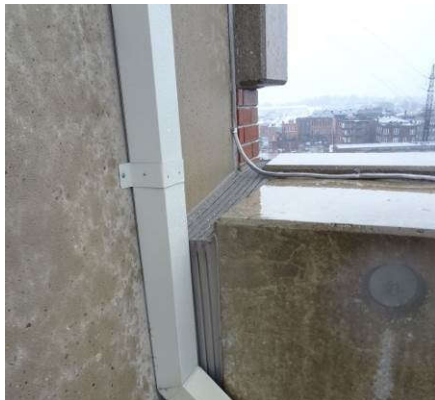
- Expansion joints are currently installed around the three stair towers (*reference Photo Nos. 21 & 22*). Expansion joints are typically created within a structure to allow for thermal movements within the structure in response to ambient temperature variation and are also sometimes necessary to separate structural elements which are anticipated to move contrary to one another due to differential settlement or potential seismic activity (such as stair towers). These expansion joints need to be closed off to prevent water infiltration through the joint opening or to allow for a smooth transition between adjoining structural elements; typically, a flexible material or gland is designed to handle the extent of movements experienced. These glands can be comprised of any number of materials and need to be tough enough to handle vehicular and/or pedestrian traffic as may be required and still allow for unimpeded pedestrian access.

Although the existing joint glands are demonstrating their age due to wear and tear, the glands appear to still be performing well. **DESMAN** recommends that the existing glands be monitored and repaired as

required; **DESMAN** recommends that an allowance be programmed accordingly for miscellaneous repair, until full replacement is warranted.

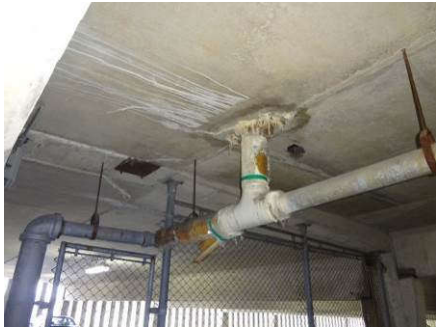
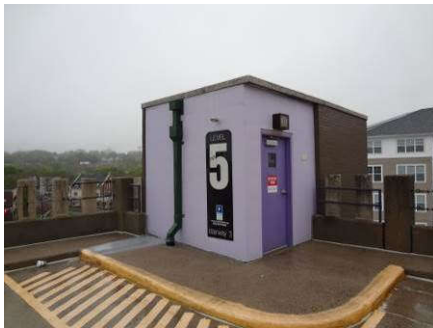
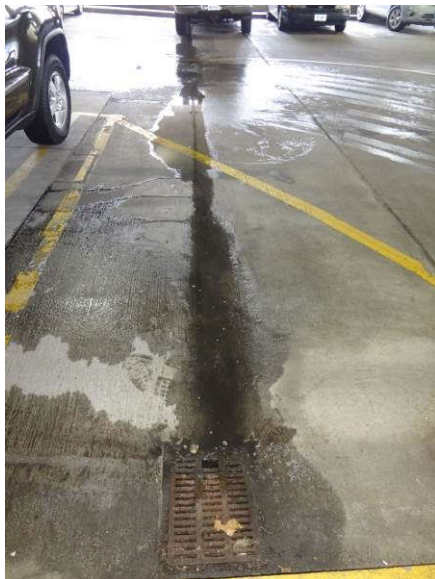
Considering the magnitude of cracking and the apparent full-depth penetration through a significant portion of the cracking in specific areas, along with the anticipated extent of slab repair, **DESMAN** now recommends that a corrosion inhibiting sealer be applied, followed then the installation of a heavy-duty traffic bearing membrane system. A combination of membrane with a healer/sealer has already been installed on the second level, above the garage office and opposite storage space below, as well as the roof level along the beam members.

- New cove joint was installed in 2010 at the majority of all vertical and horizontal interfaces throughout the garage. **DESMAN** recommends that all cove joint sealant be monitored and repaired as may be required.
- **DESMAN** noted that the roof systems above the stair/elevator towers appear to be performing well. **DESMAN** recommends that the roofing systems be monitored and repaired as may be required.

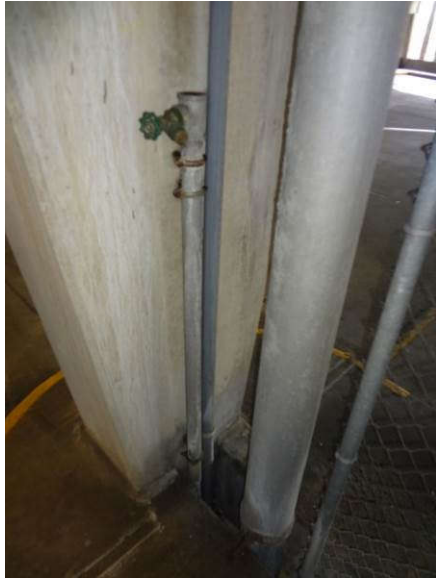
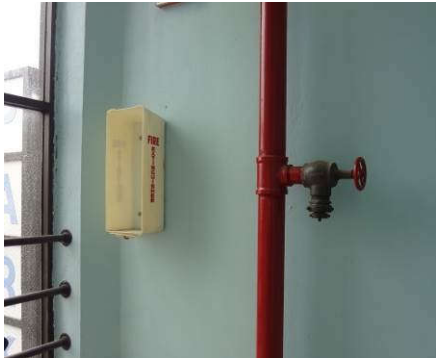
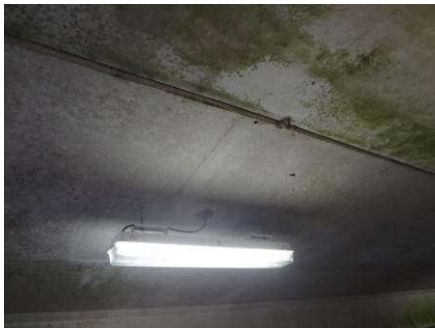
- Existing floor drainage continues to appear to perform satisfactorily with only minor pipe leakage identified. Although supplemental floor drains have recently been installed, minor areas of standing water remain, however, which can be addressed with a few more supplemental floor drains piped to the existing storm drainage system. Any drainage system within a parking facility should be flushed and tested annually to prevent debris collection and checked for system leaks (**reference Photo Nos. 28, 29 & 30**).
- Miscellaneous damaged drains and piping were observed throughout the garage, requiring repair and/or replacement. **DESMAN** recommends that all corroded grating and other components be replaced.

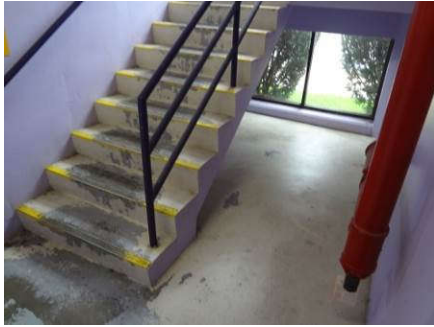
Photo No. 37

- Although the stair handrail/guardrail systems throughout the garage generally remain in good condition, **DESMAN** observed that the railings do not appear to be in compliance with current Code; as **DESMAN** understands, the applicable Code specifies that handrails are to be provided at 2'-10" from the surface of the floor with guardrails at 3'-6", as well

as no openings be greater than that which would allow a 4" diameter sphere to pass through.

At the time of modifications, **DESMAN** also recommends that the guardrail system be extended to terminate at the lower level's wall. The configuration of the guardrail results in a space below the last flight of steps, which, due to the lack of visibility may be difficult to maintain. **DESMAN** recommends that a locked gate be installed within the guardrail to allow access to the space as required.

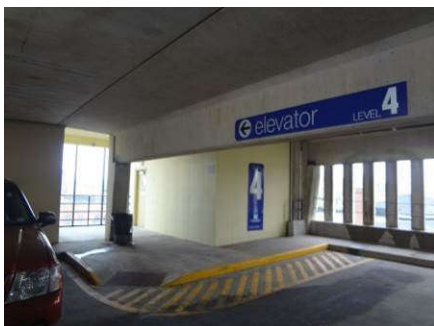
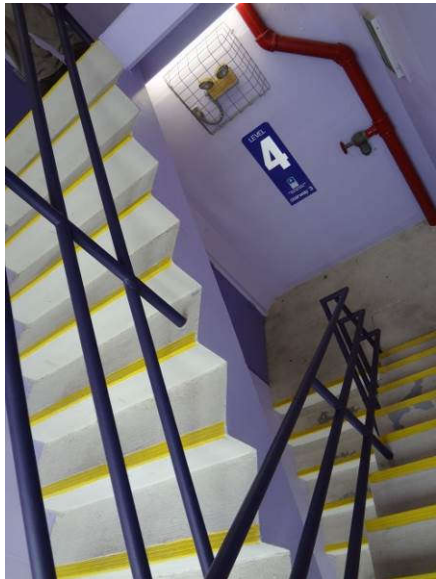
- Wayfinding signage throughout the garage appears to be in good condition, although a few isolated signs appeared to be damaged or are missing, and thus should be repaired and/or replaced as may be required; additional signs may be appropriate in isolated circumstances, such as may be related to the elevator

- Miscellaneous metal surfaces, throughout the garage, exhibit various stages of corrosion. **DESMAN** recommends that all miscellaneous metal surfaces be cleaned, primed, and re-painted (i.e. doors and frames, stair handrails/guardrails, fire standpipe, etc.), to both protect and enhance their appearance.
