# CONDITION APPRAISAL

## HAVILAND STREET PARKING GARAGE

NORWALK, CONNECTICUT

JANUARY 2026

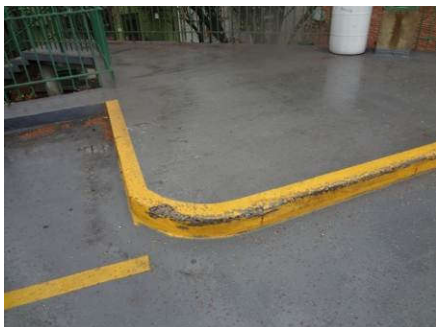
Photo No. 16

- Miscellaneous concrete spalling was observed in a limited number of areas of raised concrete curbs and vertical/wall surfaces located around the parking deck, and is being addressed as part of the current repair program (*reference Photo Nos., 16 & 17*). **DESMAN** does anticipate, though that maintenance and capital repairs will be required in the future, so therefore **DESMAN** recommends that **PN** budget accordingly

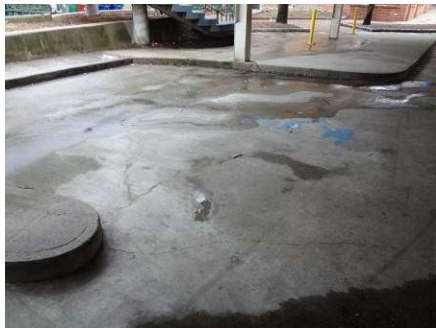
Photo No. 18

- Minor cracking, scaling, and other deterioration mechanisms exist throughout the slab-on-grade (Level 1), and is currently being addressed as part of the current repair program (*reference Photo No. 18*). **DESMAN** does anticipate, though that maintenance and capital repairs will be required in the future, so therefore **DESMAN** recommends that **PN** budget accordingly.

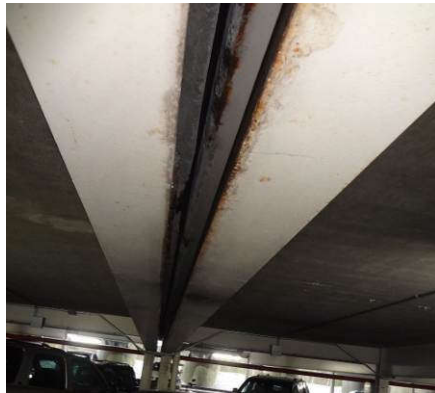
Photo No. 19

- The garage has a steel structural frame of beams and columns, which support the concrete deck; the steel frame was observed to be in good condition (*reference Photo Nos. 19 & 20*). Re-painting of the framing is being addressed as part of the current repair program, and **DESMAN** recommends that all framing be programmed for re-painting as needed, to both protect and enhance its appearance.

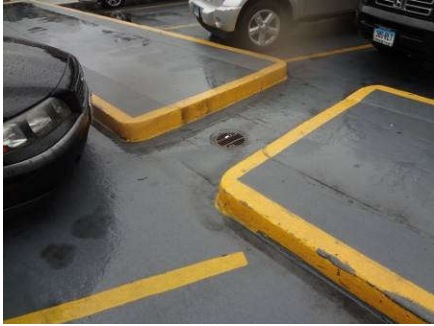
Photo No. 27

- The existing floor drains and piping will all be replaced as part of the current repair program; the existing cast iron piping will be replaced with new PVC piping (*reference Photo Nos. 27 & 28*)
- **DESMAN** recommends that the drainage system be flushed and cleaned twice yearly, in the Fall and again in the spring, to remove all debris, dirt and contaminants.
- **DESMAN** recommends that the fire protection system monitored, tested, and repaired as required, all in accordance with the appropriate operation and maintenance manuals and NFPA guidelines.

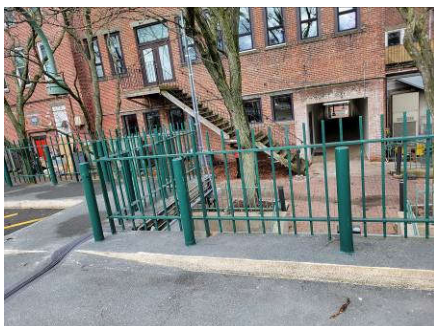
Photo No. 41

- As part of the current repair and improvement program, a new stair is being installed, to provide a more direct access route to the corridor leading to Washington Street (**reference Photo No. 41**). Following the installation, **DESMAN** recommends

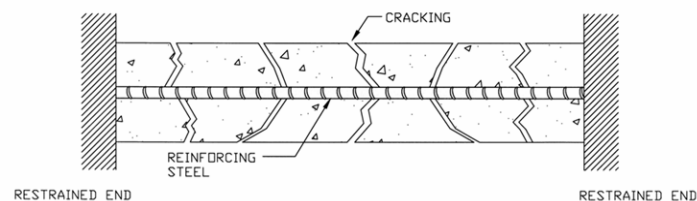
Fig. D

Volume changes due to thermal movement, shrinkage, creep, and loading can also contribute to the deterioration of reinforced concrete. These volume changes will produce stress in restrained members, often resulting in cracking of the member (**Reference Fig. D**). These cracks also provide access to water and other deterioration mechanisms to attack the member.
