CONDITION APPRAISAL

MARITIME PARKING GARAGE

NORWALK, CONNECTICUT

JANUARY 2026

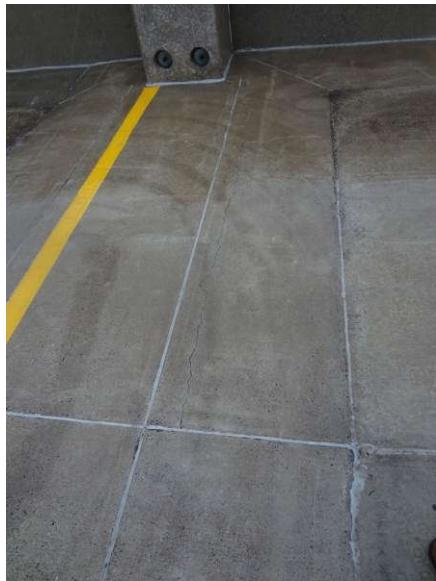
Photo No. 14

- Cast-in-place concrete aprons and pour strips are located throughout the garage, specifically along the perimeter of the decks and along the inverted tee beams; the cast-in-place concrete appears to be performing well typically. (*reference Photo No. 14*)

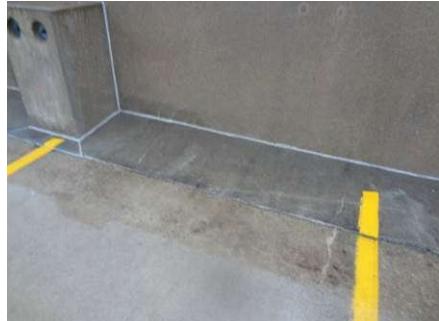
Photo No. 15

- **DESMAN** noted minor surface scaling and shallow-depth delamination and/or spalling throughout the garage, particularly in those areas constantly exposed to moisture (i.e. adjacent to drains, adjacent to the ramps, exposed on the roof level, etc.) Scaling can be caused by cyclical freeze-thaw, and is typically exhibited by pitting on the concrete surface and an exposure of the aggregate within the concrete matrix. The reinforcing steel can become exposed, allowing further moisture penetration. **DESMAN** recommends that the scaling and shallow-depth deterioration be repaired using an appropriate epoxy/aggregate repair mortar, prioritizing the roof level. (*reference Photo No. 15*)

Any recommended concrete repair work should be coordinated with waterproofing/sealant work needed, as described later in this report.

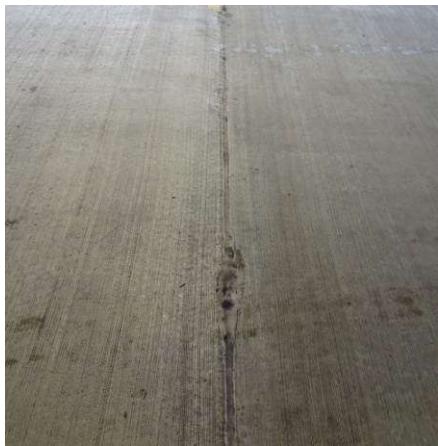
Photo No. 18

- Failed joints are observed throughout the garage. The failed sealant consists of a variety of failure mechanisms, such as debonding from the adjacent tee surfaces which can occur from poor surface preparation; insufficient grinding of the edges, leaving rough surfaces, creates an increased susceptibility to premature failure of the joint material. (**reference Photo Nos. 18, 19, 20 & 21**)

- Repairs to leaking tee-to-tee joints typically requires that old sealant material be entirely removed down to bare concrete, the edges detailed and the substrate properly primed prior to new polyurethane sealant material being installed. Limited "spot" repair of tee-to-tee joints can be problematic as new polyurethane sealant materials do not adhere well to preexisting or previously cured polyurethane sealant. Spot repairs can be accomplished but preexisting sealants need to be

- Considering the apparent age of the existing sealant material and the magnitude of shear connector repairs, **DESMAN** recommends full removal and replacement of the tee joint sealant be programmed. At the time of sealant replacement, all edges should be properly ground smooth to facilitate appropriate material bonding.

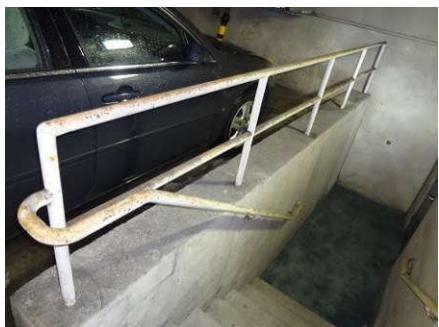
Photo No. 51

- **DESMAN** observed however that the guardrail system does not extend to the lowest level's wall. The configuration of the guardrail results in a space below the last flight of steps, which, due to the lack of visibility may be difficult to maintain. **DESMAN** recommends that the guardrail be extended to prevent unauthorized access to this area, and that a locked gate be installed within the guardrail to allow access to the space as required.
