CONDITION APPRAISAL

SOUTH NORWALK RAILROAD TRAIN STATION PARKING GARAGE

NORWALK, CONNECTICUT

JANUARY 2026

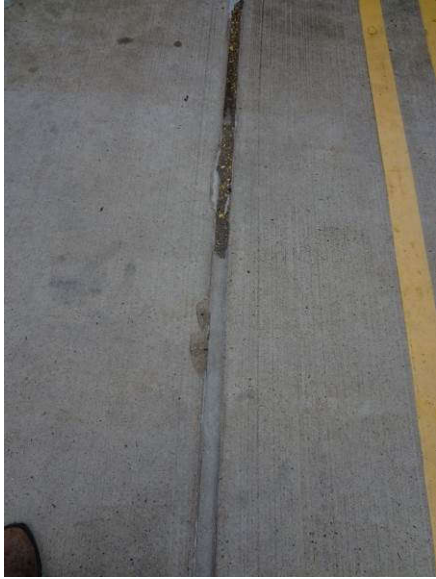
Photo No. 8

- As a general rule, the life expectancy of tee-to-tee joint sealant is between 8 to 12 years depending on exposure and level of usage (*reference Photo Nos. 8, 20 & 21*). Roof level joints, though, are exposed to more aggressive circumstances due to environmental conditions and snow plow damage, and lower levels experience comparatively more traffic than the upper levels of the facility.

Miscellaneous sealant between adjacent precast concrete tees was observed to be exhibiting varying stages of age, which has led to some corrosion related deterioration at the tee connections. Although limited "spot" repairs have been performed, **DESMAN** typically recommends that more comprehensive repairs be programmed.

Limited "spot" repairs of tee-to-tee joints can be problematic as new polyurethane sealant does not adhere well to pre-existing or previously cured polyurethane sealant. "Spot" repairs can be accomplished, as evident from the recently performed repairs, but the pre-existing sealants must be thoroughly cleaned and wiped down with solvents to soften the surface and enhance the bond between old and new materials. Unless there is only limited tee-to-tee joint failures along a 60 foot parking bay, **DESMAN** typically recommends that the entire length of tee joint be removed and repaired in its entirety

For budgeting purposes, **DESMAN** recommends that all the joint sealant be removed and new sealant installed. While "spot" repair may be acceptable along certain joints, full replacement will provide a uniform life expectancy for all the sealant, as well as avoiding varying and multiple warranties on the new sealant. **DESMAN** recommends that the joint sealant be reviewed on an annual basis; based upon the actual observed condition, it may be acceptable to perform "spot" repairs in lieu of full replacement, at which time **DESMAN** would assist **PN** in adjusting its budget.

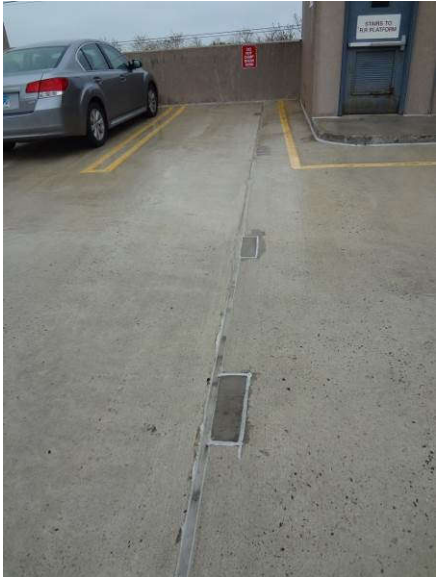
Photo No. 9

- During erection and placement of the individual precast concrete double tee deck elements, each tee is tied to the adjoining tee with embedded shear connection assemblies spaced periodically along the length of the tee (**reference Photo Nos. 8, 9, 10 & 11**). Depending on the depth of the embedment, and the care utilized during the welding process to connect the adjoining tees, there can be instances where nominal spalling at various connections might occur. If the precast concrete at the shear connections retain sufficient moisture, the heat generated during welding can vaporize the moisture into steam causing tensile failure in the concrete and nominal surface spalling at the connections.

The surface spalling at the shear connections can also be the result of insufficient embedment depth of the shear connection assembly and the surrounding concrete being stressed beyond its tensile capacity during erection, unintended restrained thermal movements in the entire structure in response to ambient temperatures. Failure can also potentially occur due to a temporary overstress condition as a vehicle or combination of vehicles move across the deck and up through the garage, or during snow removal operations. Interim repairs have been performed as **DESMAN** noted that select shear connector assemblies associated spalled/delaminated shallow-depth

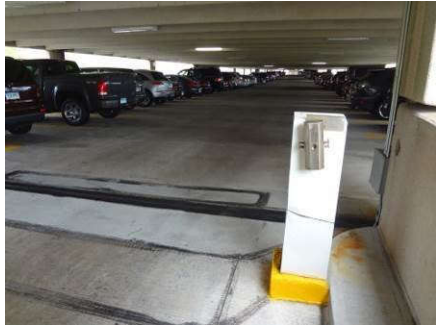
Photo No. 48

- Oil and debris, as well as bird guano, have collected throughout the garage in isolated areas. Although the S.N.R.R. Garage generally appears to be in a clean condition, grease and oil drippings from vehicles are inevitable and birds will seek any nesting opportunity.

The S.N.R.R. Garage possesses the benefit of having a washdown system installed, with risers accessing the roof level. With typical degreasers employed on a semi-annual basis, **DESMAN** recommends that a washing of the deck be performed to eliminate dirt and debris that hold moisture and chlorides which can be damaging to the concrete deck. Although limited netting has been installed in the past to minimize nesting, providing a comprehensive bird

control system can be challenging and expensive; **DESMAN** understands that obtaining the services of a professional pest management company had been recommended in the past. At the time of the garage cleaning, **DESMAN** also recommends that all ledges and other nesting locations be cleaned, removing any bird guano that may provide a health hazard. **DESMAN** also recommends that regularly scheduled testing and inspection be performed on the washdown system, as well as cleaning and maintenance of the system components in accordance with O&M recommendations, to confirm proper operational capacity of the system.
