CONDITION APPRAISAL

YANKEE DOODLE PARKING GARAGE

NORWALK, CONNECTICUT

JANUARY 2026

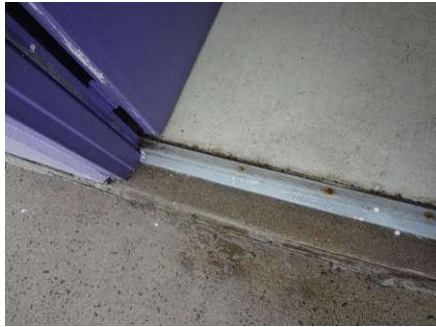
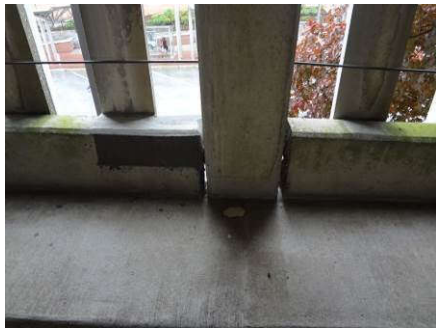
Although the existing joint glands are demonstrating their age due to wear and tear, the glands appear to still be performing well. **DESMAN** recommends that the existing glands be monitored and repaired as

required; **DESMAN** recommends that an allowance be programmed accordingly for miscellaneous repair, until full replacement is warranted.

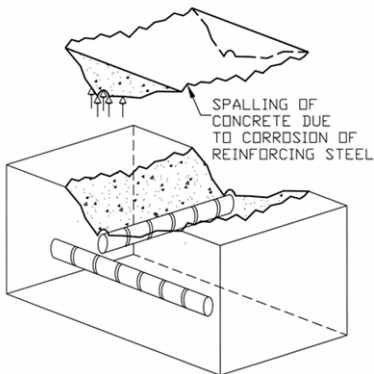
Fig. A

Concrete is a porous material, susceptible to water penetration which can result in increased potential for deterioration. Corrosion of reinforcing steel is an electrochemical process accelerated by the presence of water acting as an electrolyte. In addition, water penetrating into concrete (**Reference Fig. A**) can carry water-soluble chlorides (de-icing salts) to the reinforcing. The combination of chlorides and water further accelerates this corrosion process.

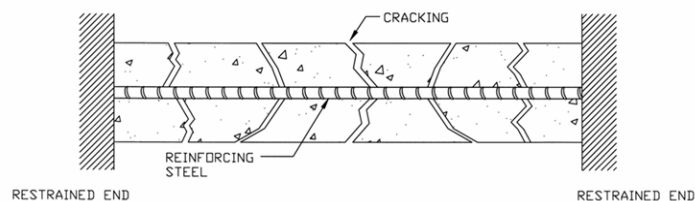
Fig. D

Volume changes due to thermal movement, shrinkage, creep, and loading can also contribute to the deterioration of reinforced concrete. These volume changes will produce stress in restrained members, often resulting in cracking of the member (**Reference Fig. D**). These cracks also provide access to water and other deterioration mechanisms to attack the member.
